Norddeutsche Affinerie Hamburg, Cooling Water Pipe

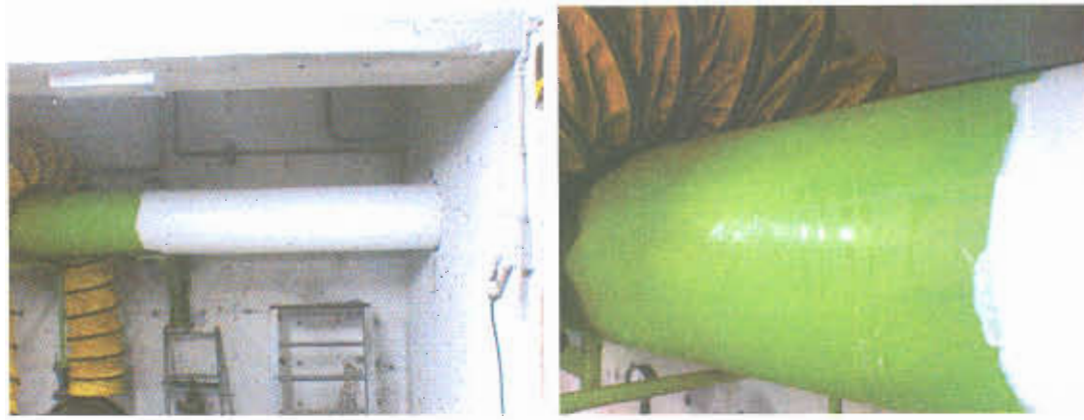
Room temperature 16°C, Temperature of pipe surface 9°C, little condensation

MMG strongly corrodes the green synthetic resin varnish

Condensation wiped off, application of MMG coating, MMG adheres well

MMG plus old varnish scraped off, no problems with new MMG application

HSC 300 applied by brush and scraper, thickness approx. 3 mm

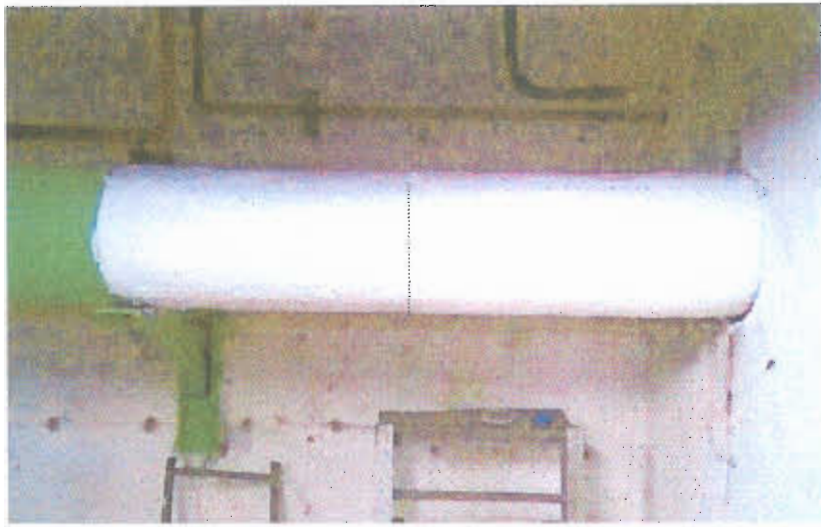
Afterwards pipe surface temperature 6.4°C with condensation,
HSC surface temp. 3 mm thick : 8.8°C without condensation
HSC surface temp. 6 mm thick : 10.3°C without condensation

Overcoating with STH will be applied on 3/13, temp. measurements will be repeated conclusively
