BUCKTOWN COMMONS

2011

UPDATE

APPLICATION CERTIFICATION

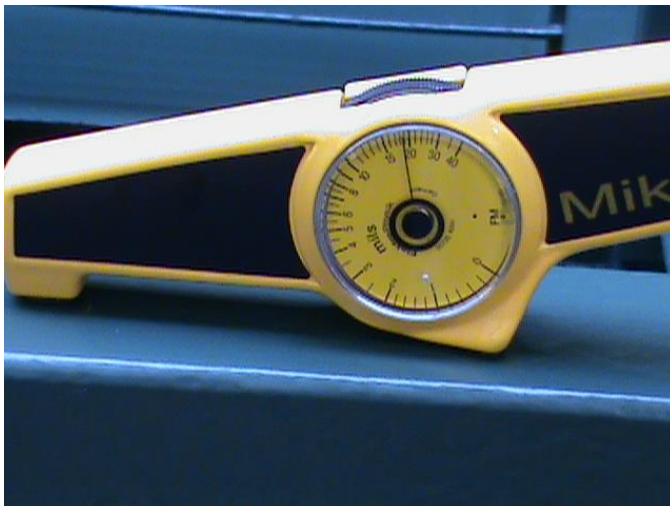
18 Mils DFT

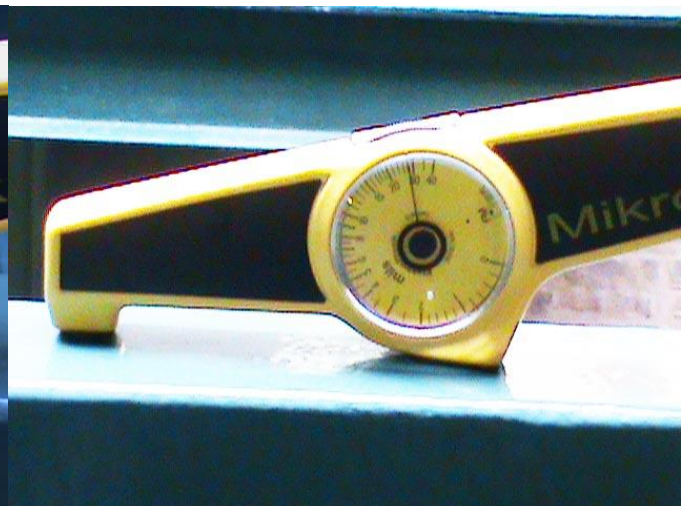
22 Mils DFT

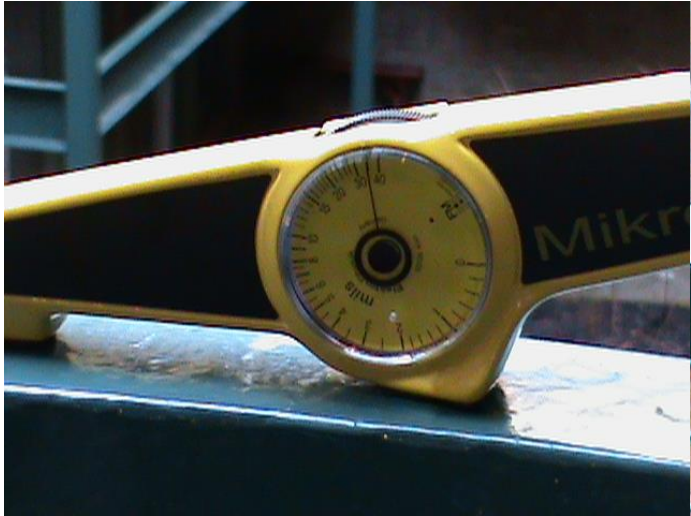
35 Mils DFT

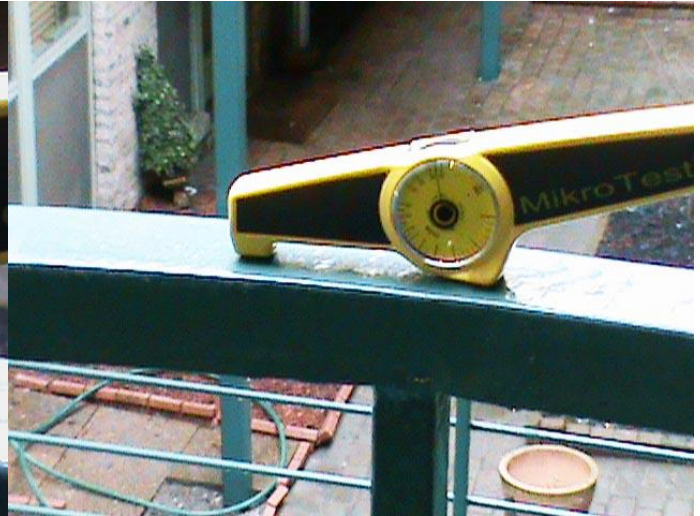
35 Mils DFT

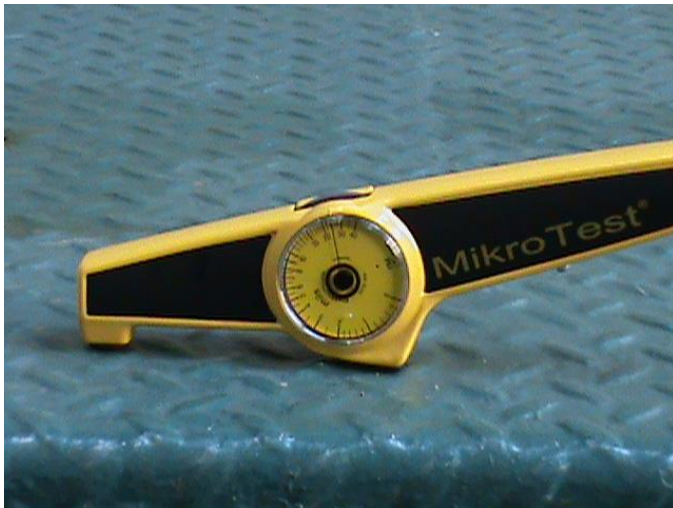
24 Mils DFT

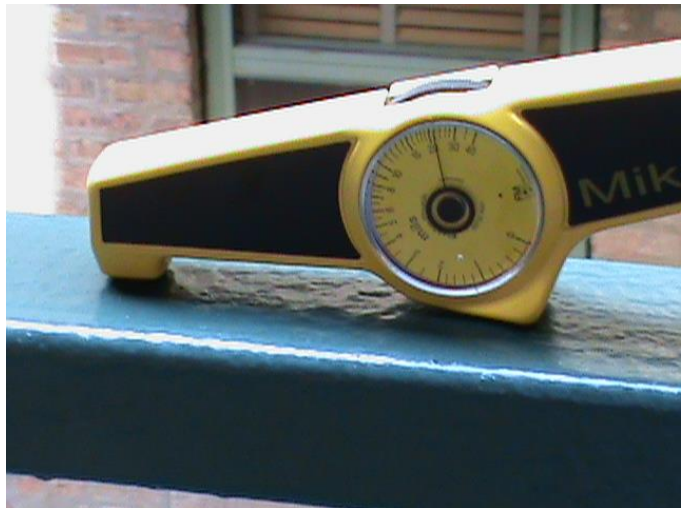
22 Mils DFT
