## **CHELSEA GARDENS**

## 1998

**RUST GRIP** ® top coated with **ENAMO GRIP** ®

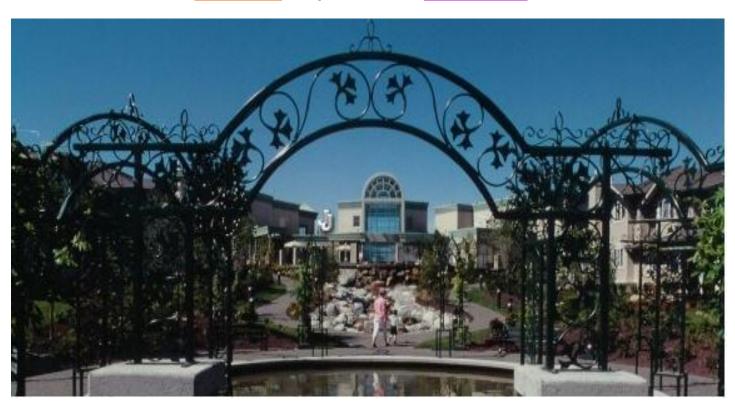
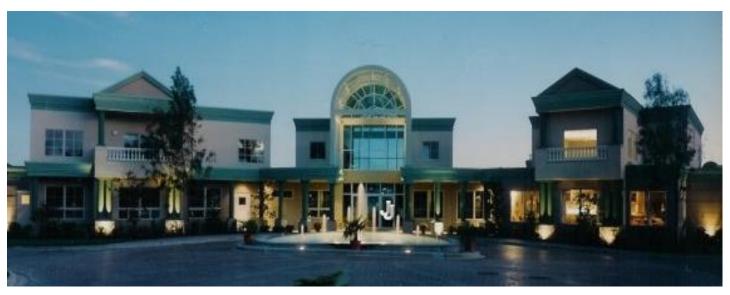
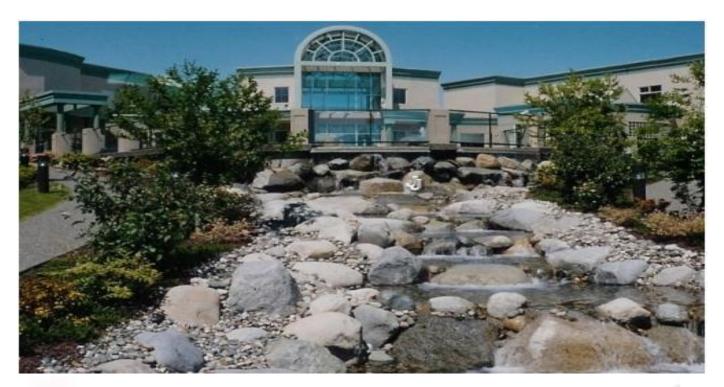
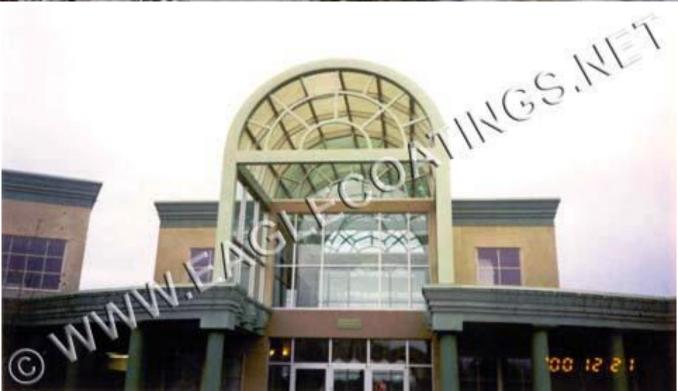
This metal arch was being attacked by the chlorine in the swimming pool below. The Epoxy coating had completely failed after about 2 years. In 1998 we encapsulated the metal first with <u>RUST GRIP</u> ® and then top coated with 2 coats crosshatched of <u>ENAMO GRIP</u> ®This picture was taken in 2000 on our two year follow up. In 2010 the coating system still looks like new.
