SUPERIOR PRODUCTS INTERNATIONAL II, INC.

STEEL MANUFACTURING PLANT

Test Areas

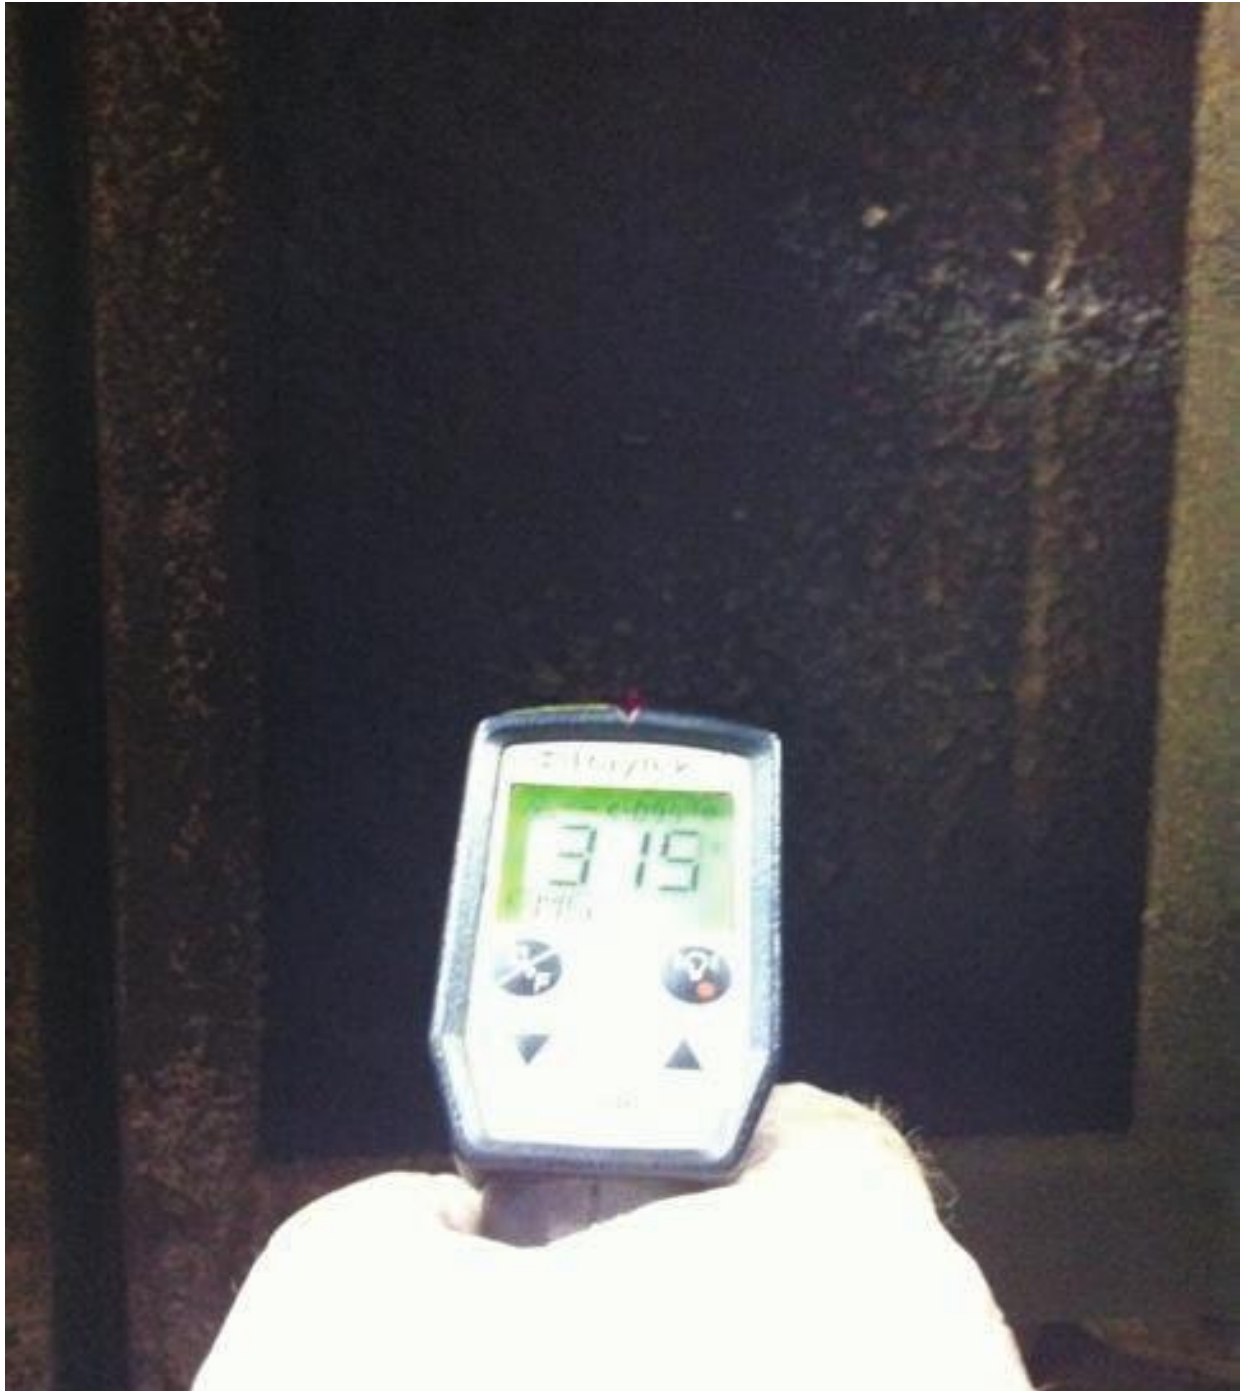
When the team came back to the steel manufacturing plant to check the charred HPC and take readings, the exterior of the HPC was reading at 315F (157C) on the surface. Before the HPC charred, it was reading 160F (71C) and therefore had an increase of 155F (86C) which seemed to show that HPC was failing and not holding the heat from the metal surface. The original surface temperature of the metal when we applied HPC was 500F (260C). Picture number 1 shows the reading on top of the exterior of the blackened HPC.

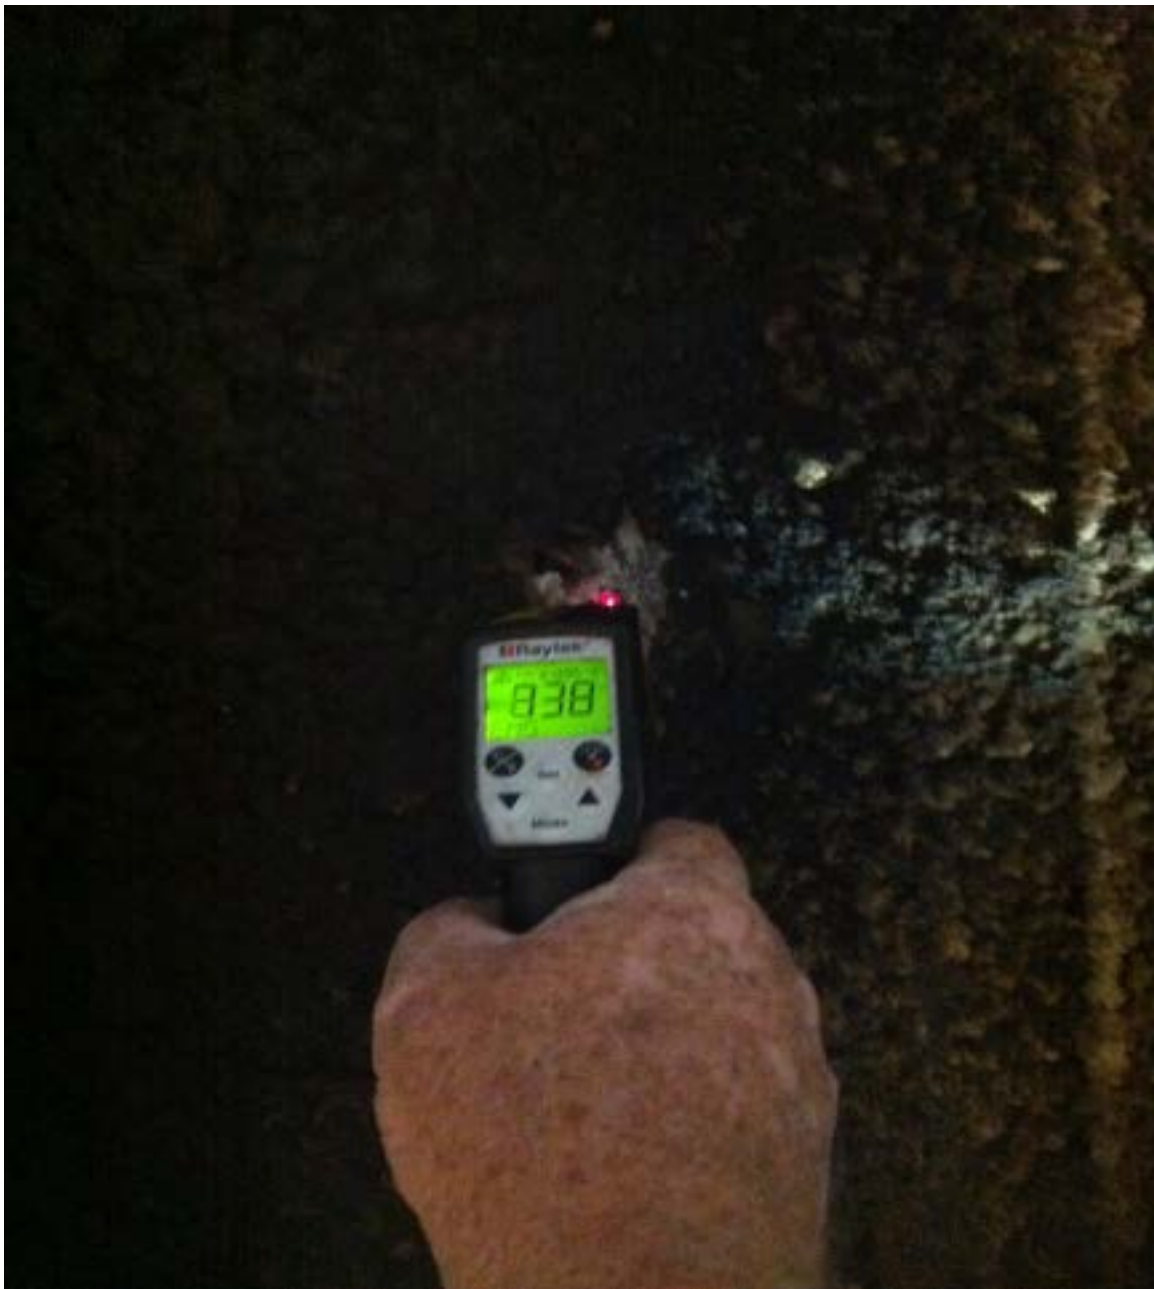
The second picture shows the metal surface after we scraped back some of the charred HPC to expose the metal surface and find the temperature behind the HPC to see how well HPC was insulating and holding the heat on the surface of the metal. The metal temperature under the HPC is now 838F (448C). This surprised the entire engineering staff because they now understood that even though the HPC has blackened from the increased heat and too little thickness, it was working very well and had increased the heat held on the metal surface from 500F (260C) to 838F (448C) or was holding the surface heat more efficiently by 68%. The BTU savings from lost without having HPC was in the millions of BTUs and the savings were huge and enough to pay for the coating within months of application. See the following picture where they scrapped the HPC off the surface to take the reading. Just enough HPC was removed to take a reading.

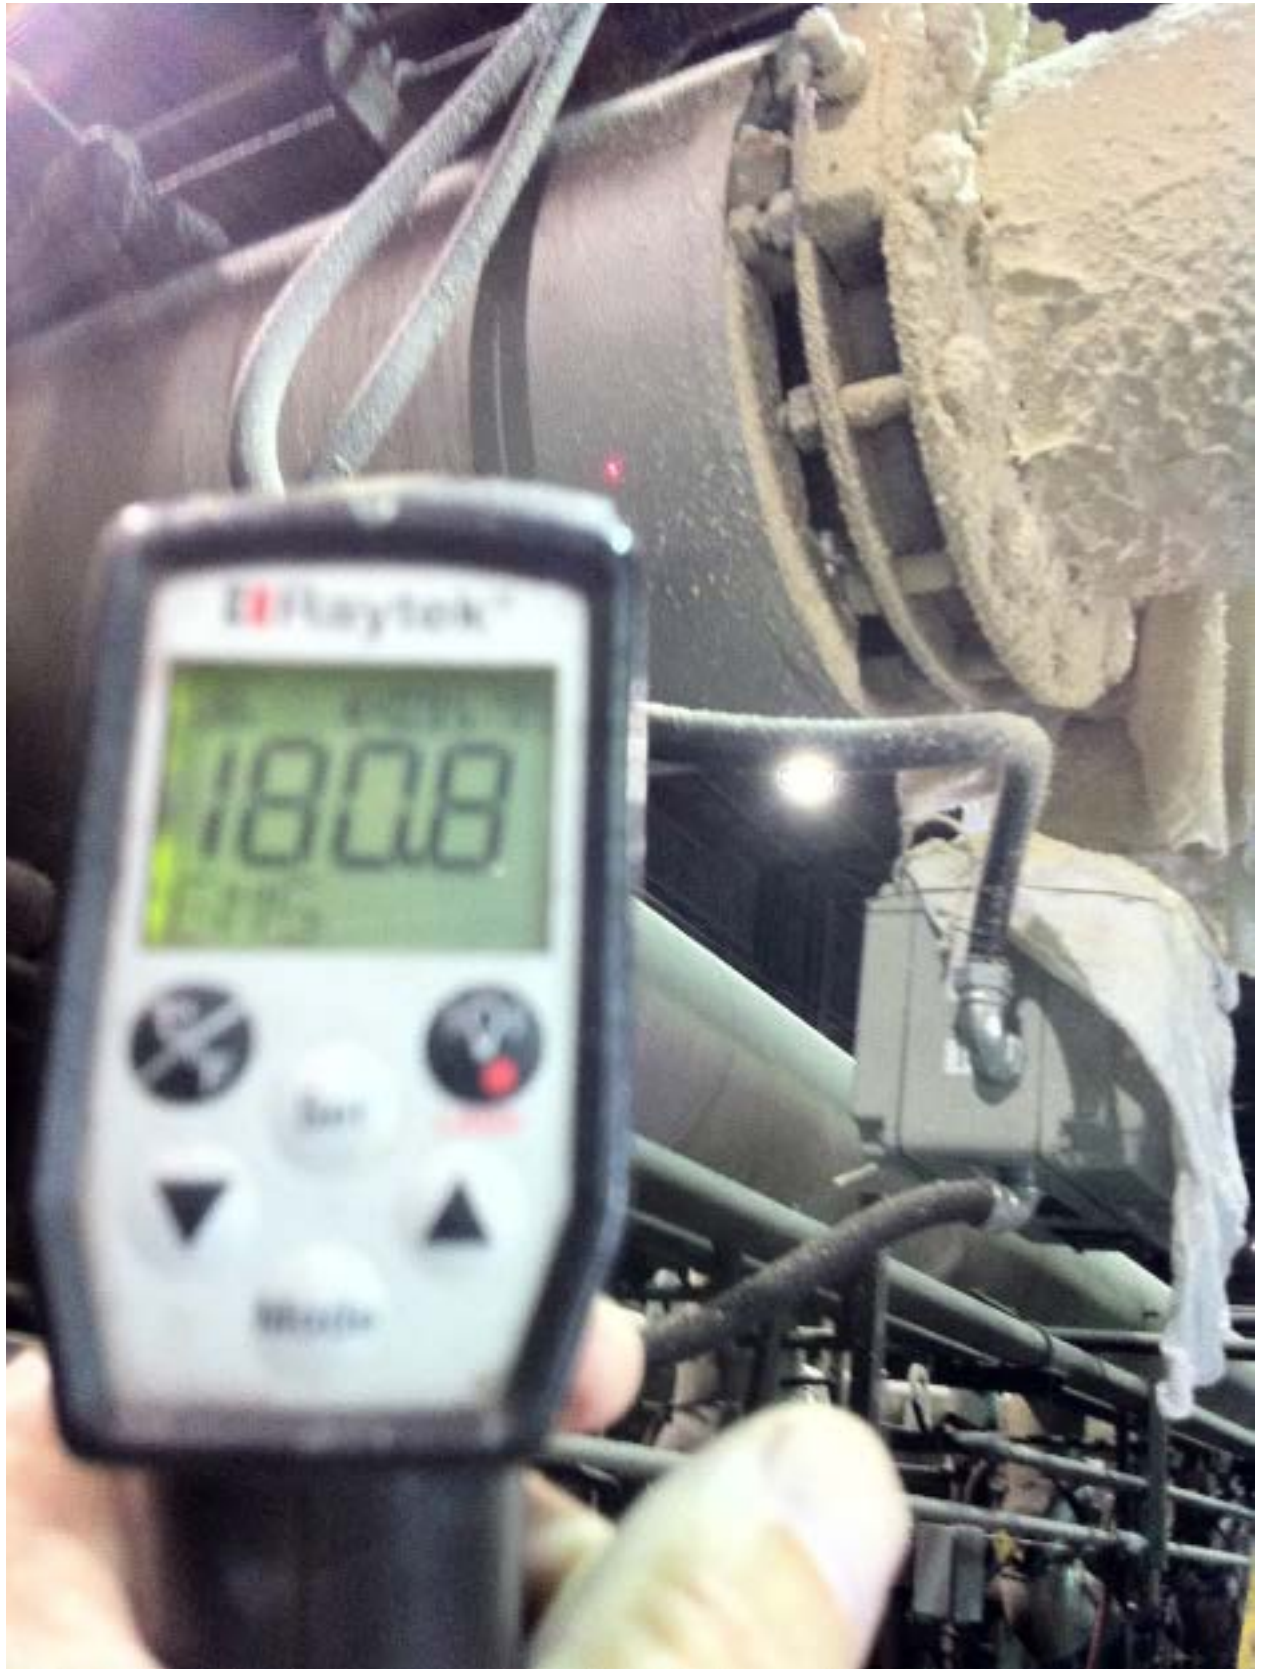
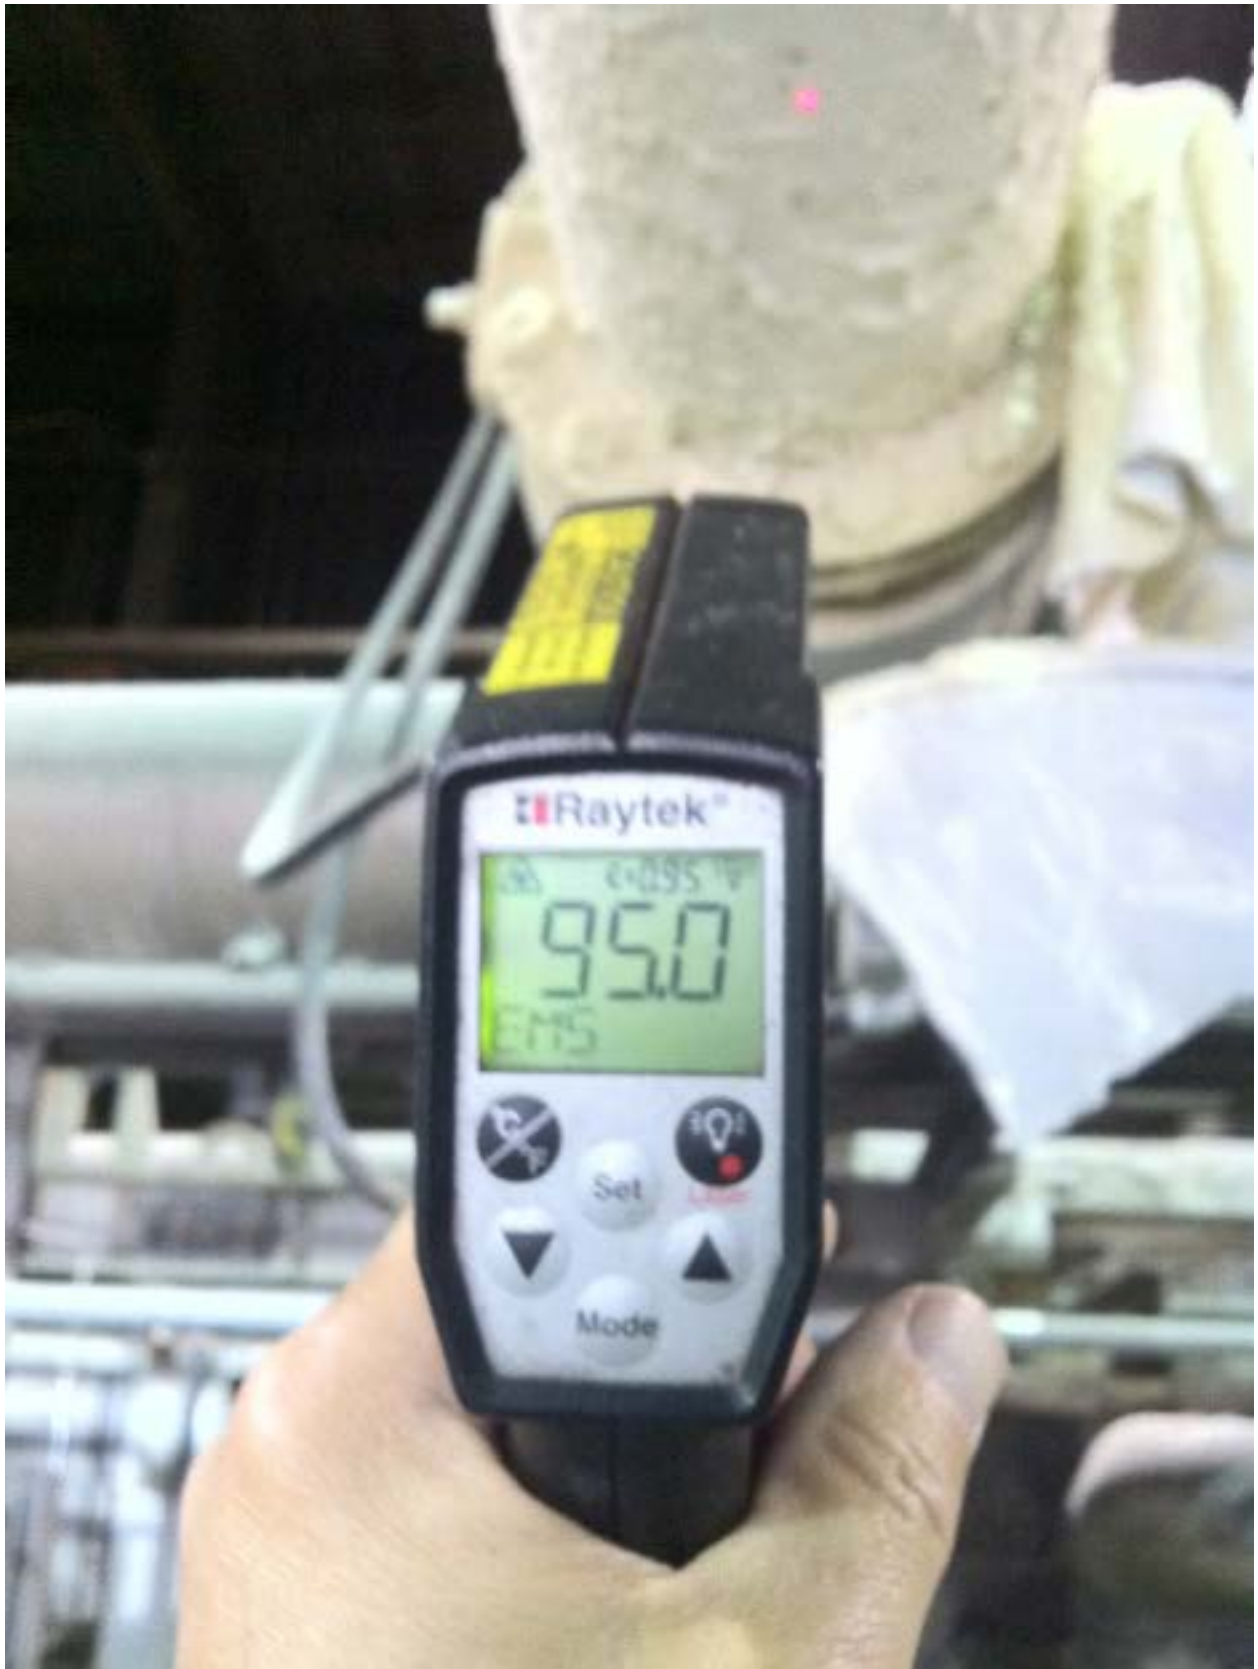
Finished temp on the HPC at around ¼" thickness. Temp on the jacket next to the bolt connector area. Fairly dramatic difference.

Second set of Pictures is the standard metal jacket over 3" (7.5cm) of silica/rock wool. Second Picture is 250 mils (6mm) of HPC directly over pipe after removing jacket and silica.

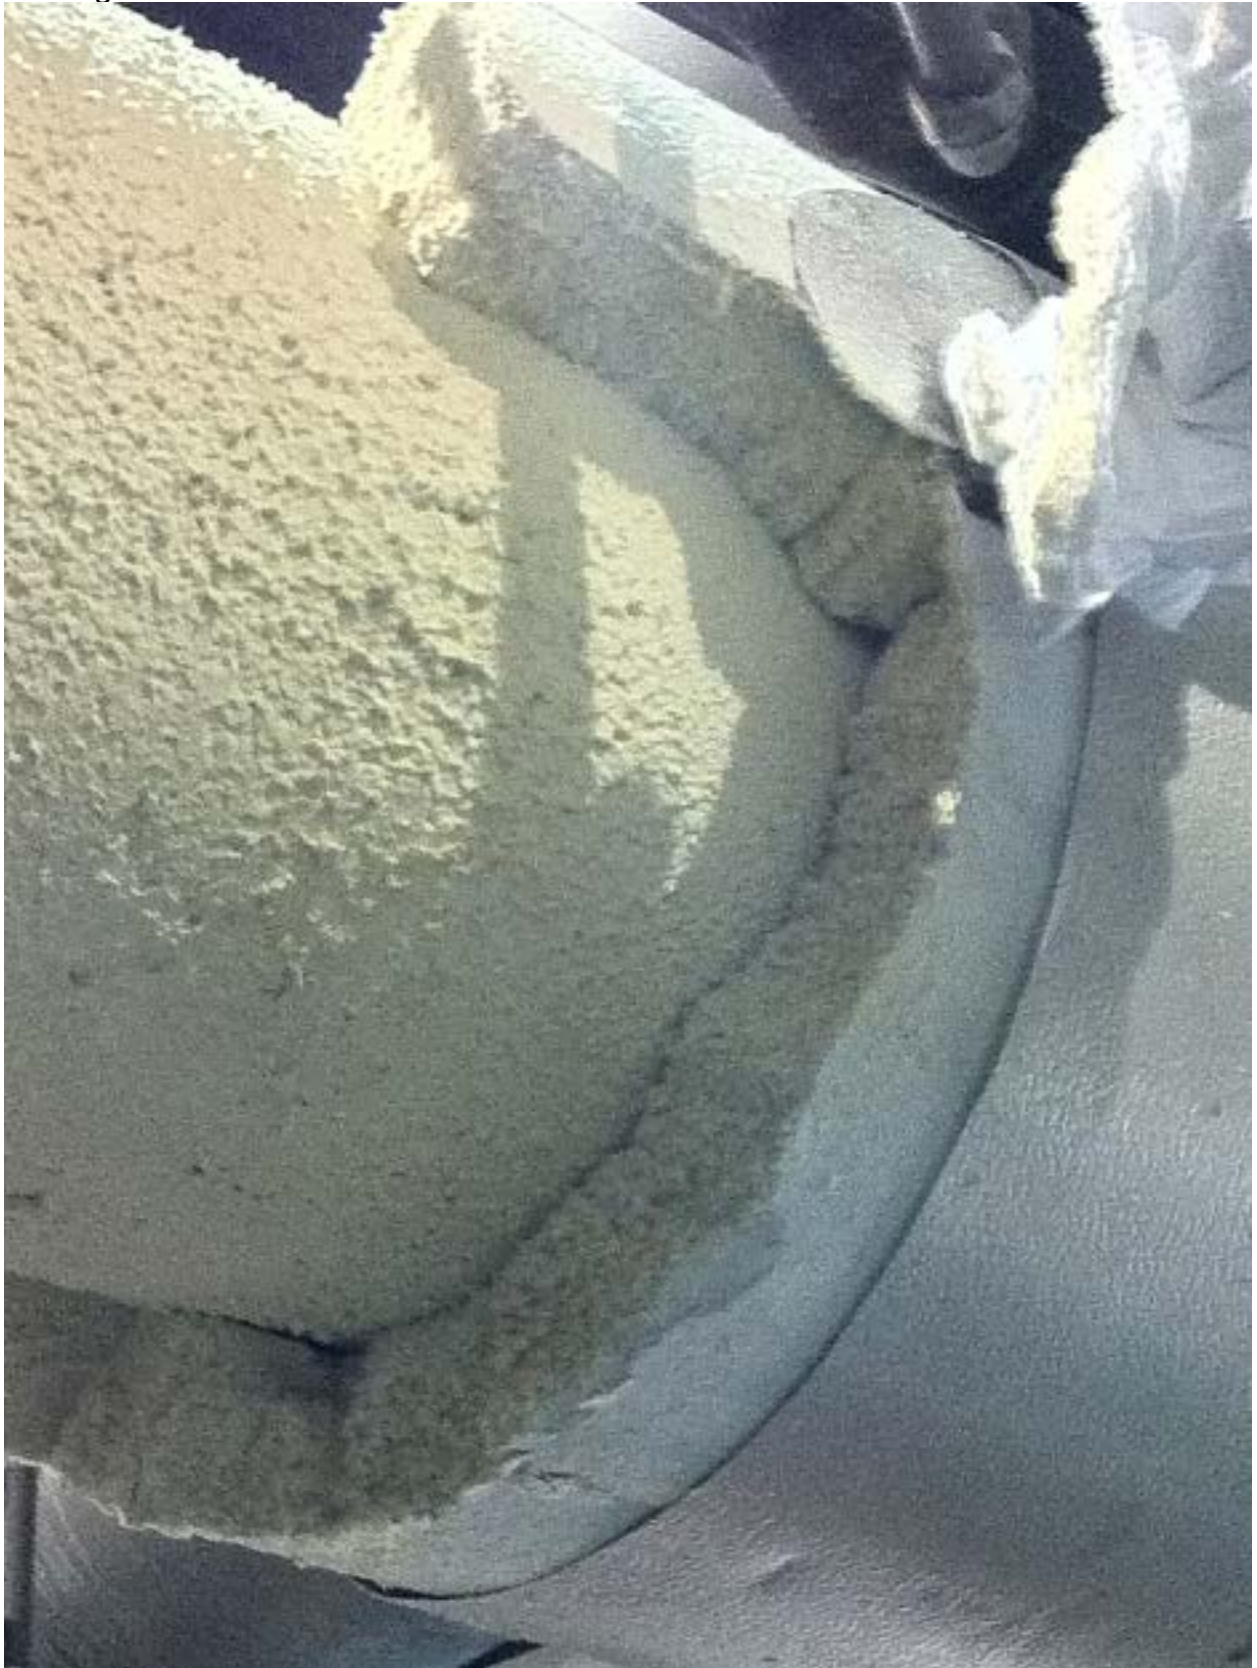
3. Third set of photos:

Interesting photo of the rock wool insulation and the exterior jacket. The temps of both the rock wool and the jacket are basically the same. Clearly shows thermal equilibrium of the rock wool. The heat is transferring in equal amounts through the rock wool to the jacket. R rating = 0.

The heat has already loaded (fully) into the rock wool and is now passing the heat through at a constant rate. At this point, there is no R value or K value of heat resistance. After the material fully loads, the resistance falls to "0".

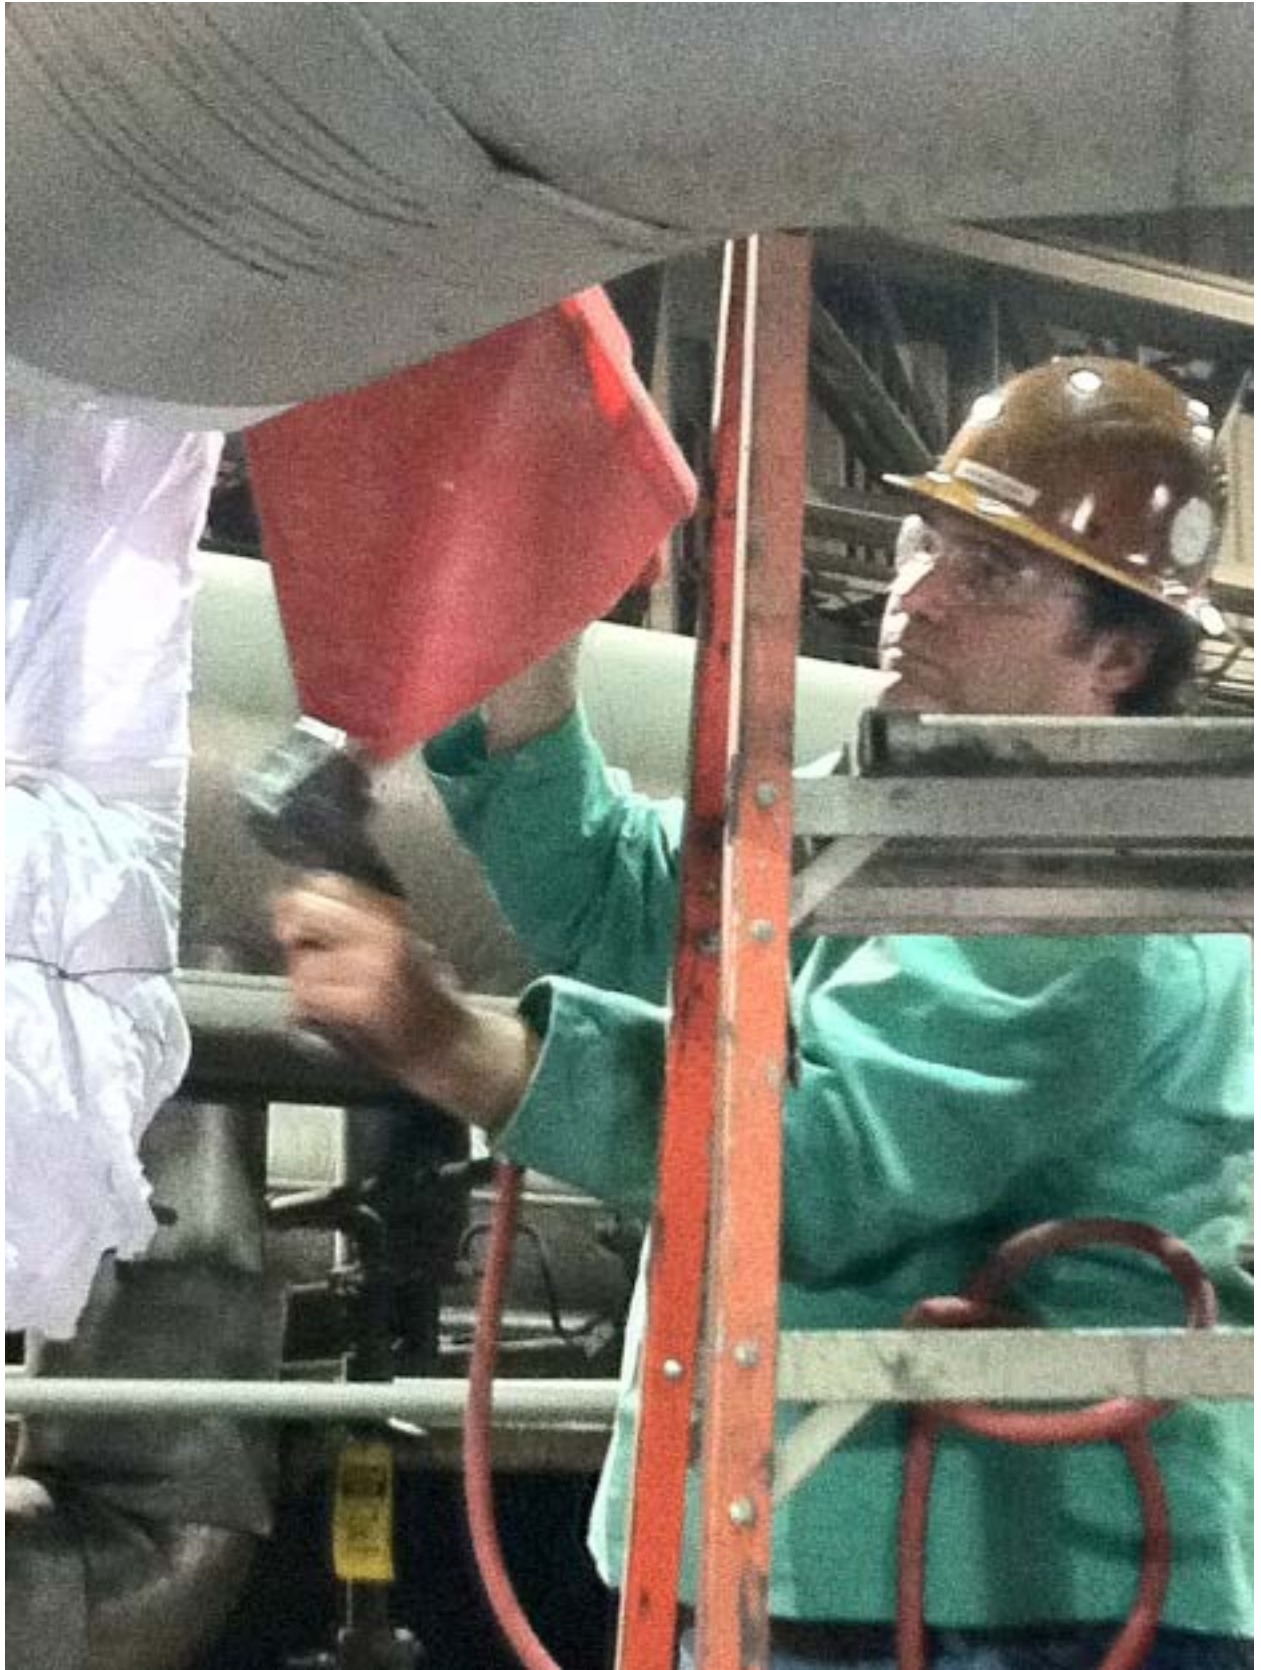
4. Fourth set of pictures:

Steve applying HPC. Reading at around a 1/16" (62 mils or 1.6mm) thickness.
The 3" (7.5cm) of rock wool and metal jacket is 139F (59.4C).
The 62mils (1.6mm) of HPC is 102F (39C).
Difference of 37 F (20C) with only 62mils or 1.6mm).
