**Testing Results for RUST GRIP Coating After 1000,
5000, and 10000 Hours of Exposure in Ultraviolet and
Salt-Spray Chambers—Blistering and Rusting
Evaluation**

**Superior Products International II, Inc.
10835 W. 78th Street
Shawnee, Kansas 66214**

**Southwest Research Institute®
6220 Culebra Road
San Antonio, Texas 78238-5166**

November 2014

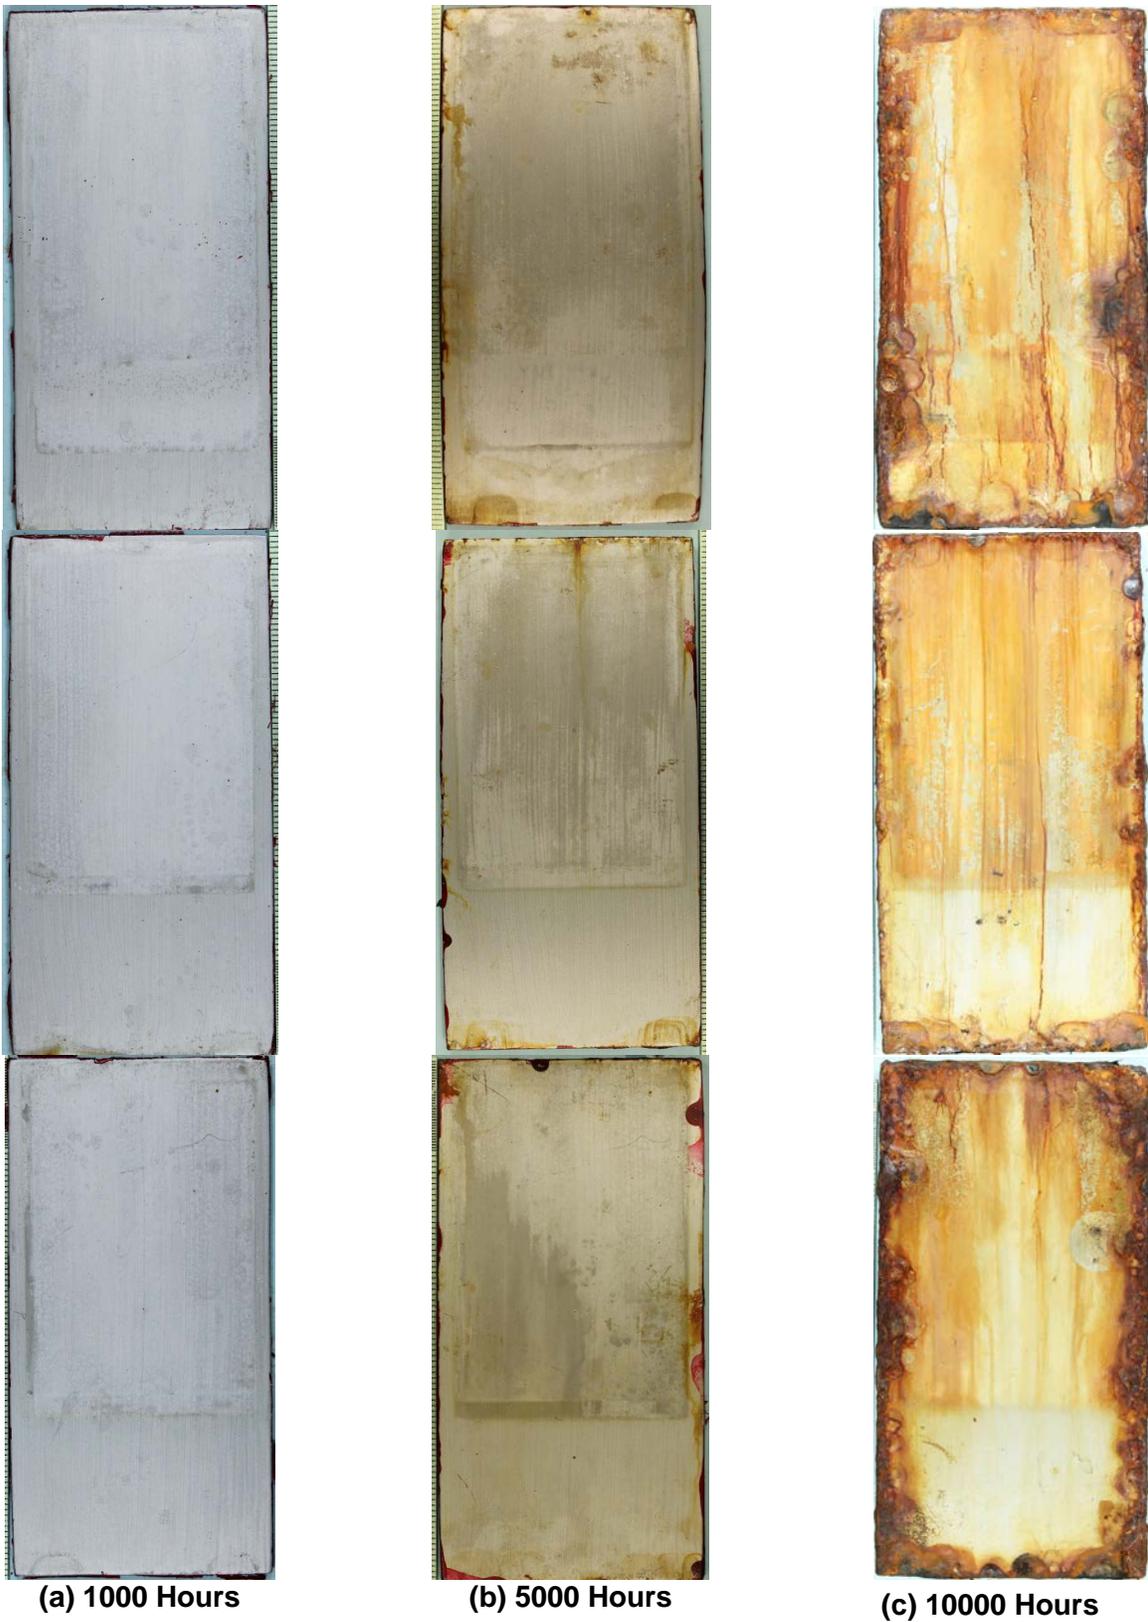
Figure 1. Images of the Three RUST GRIP Coupons After (a) 1000, (b) 5000, and (c) 10000 Hours of Exposure

Overtime, the paint releases the leachate due to its chemical interaction with the salt solution. The leachate causes the yellowish red color on the coupons' surfaces in Figures 1(b) and 1(c).

The coupons' surfaces are only partially exposed to the UV radiation in the UV chamber. If there is any effect of UV radiation on corrosion performance, it should produce a marked change in coating color and can be distinguished by two shades on a coupon surface. In Figure 1, there are two visible shades of coating colors on all three coupons after 1000, 5000, and 10000 hours of exposure. The UV exposure does not affect its corrosion performance as there . The coating does not show any marked change in rusting where discoloration due to UV exposure has occurred. This proves that even though UV exposure causes discoloration of the coating, it does not affect its corrosion performance.

2.1 Blistering Evaluation: As seen in Figure 1, the coupons shows no signs of blistering after 1000, 5000, and 10000 hours of exposure throughout the their surfaces except on edges of the two coupons. The blistering is so minor that it is not even visible in the images presented in Figure 1. This minor blistering is due to the edge effects and not due to the coating characteristics. The coating pass according to ASTM D714–02 because of no signs of blistering in the three coupons' surfaces which are not affected by the edge effect.

2.2 Discoloration: The UV exposure causes discoloration in the coating but does not affects its corrosion performance. Figure 1 shows visible signs of discoloration in the coupons after 1000, 5000, and 10000 hours of exposure. The coupons surfaces after 5000 and 10000 hours of exposure show visible signs yellowish red color through their surfaces. This is due to the leaching of a paint solution which was applied on the edges of the coupons. The paint solution was applied to minimize edge effect during the testing. The applied paint solution is red in color, and its leachate due to its interaction with the salt solution is yellowish red.

2.3 Rusting Evaluation: The degree of rusting on the three coupons is evaluated in accordance with ASTM D610–08. After 1000 hours of exposure, none of the three coupons show rusting and the three coupons are rated 10. This rating means that up to 0.01 percent of the coupon surface has rusted. After 5000 hours of the exposure, the top coupon in Figure 1(b) shows signs of rusting with pin point corrosion spots. Similarly, the middle coupon of Figure 1(b) also shows few pin point corrosion spots, but less compared to the top coupon in Figure 1(b). As seen in top coupon of Figure 1(b), few pinpoint corrosion spots are noticed. The bottom coupon in Figure 1(b) does not show any rusting which is visible with bare eyes. Considering the rusting in the three coupons after 5000 hours of exposure, the top coupon of Figure 1(b) is rated 9-P, and the remaining two coupons are rated 10. After 10000 hours of the exposure, the corrosion spots seen in Figure 1(b) persist, but no new corrosion spots could be located on the coupons' surfaces that were un affected by the edge effect. Considering this, the top coupon of Figure 1(c) is rated 9-P, and the remaining two coupons are rated 10. The rating data is summarized in Table 1.
