BUCKTOWN COMMONS

2011

UPDATE

APPLICATION CERTIFICATION

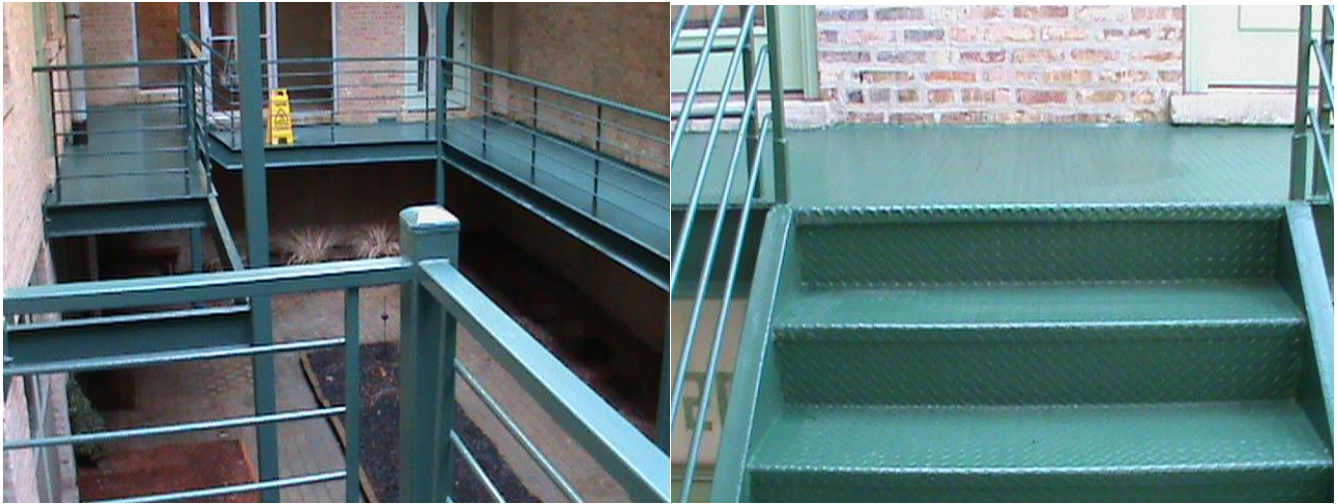
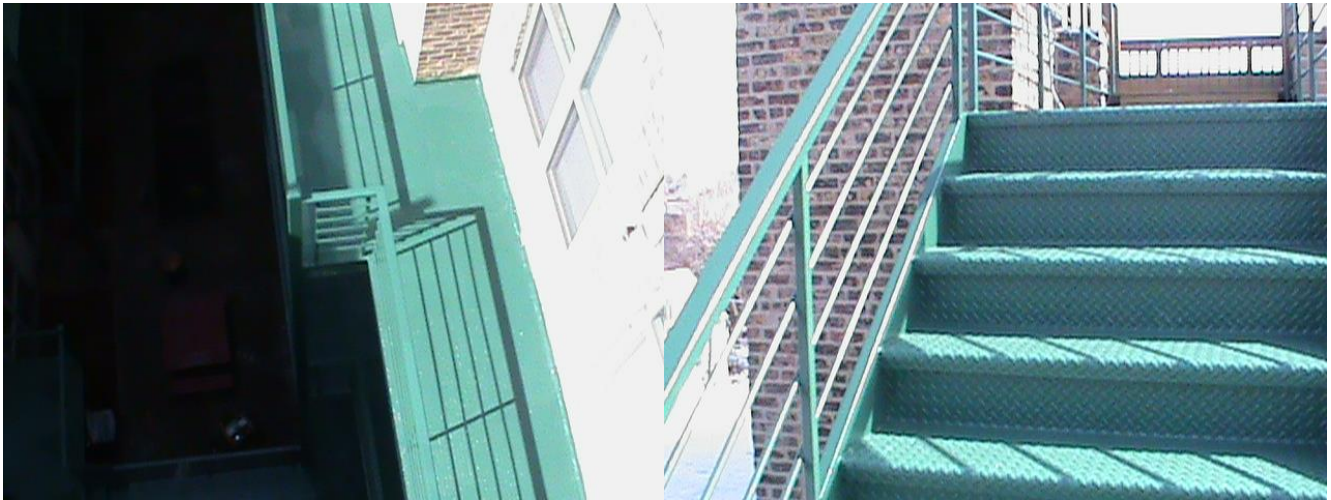
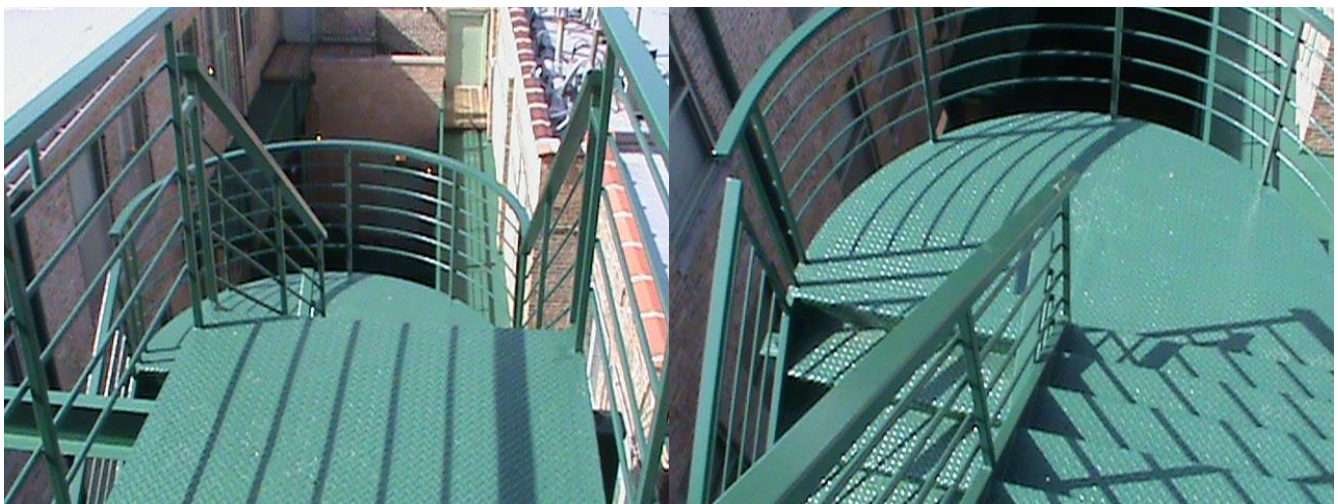
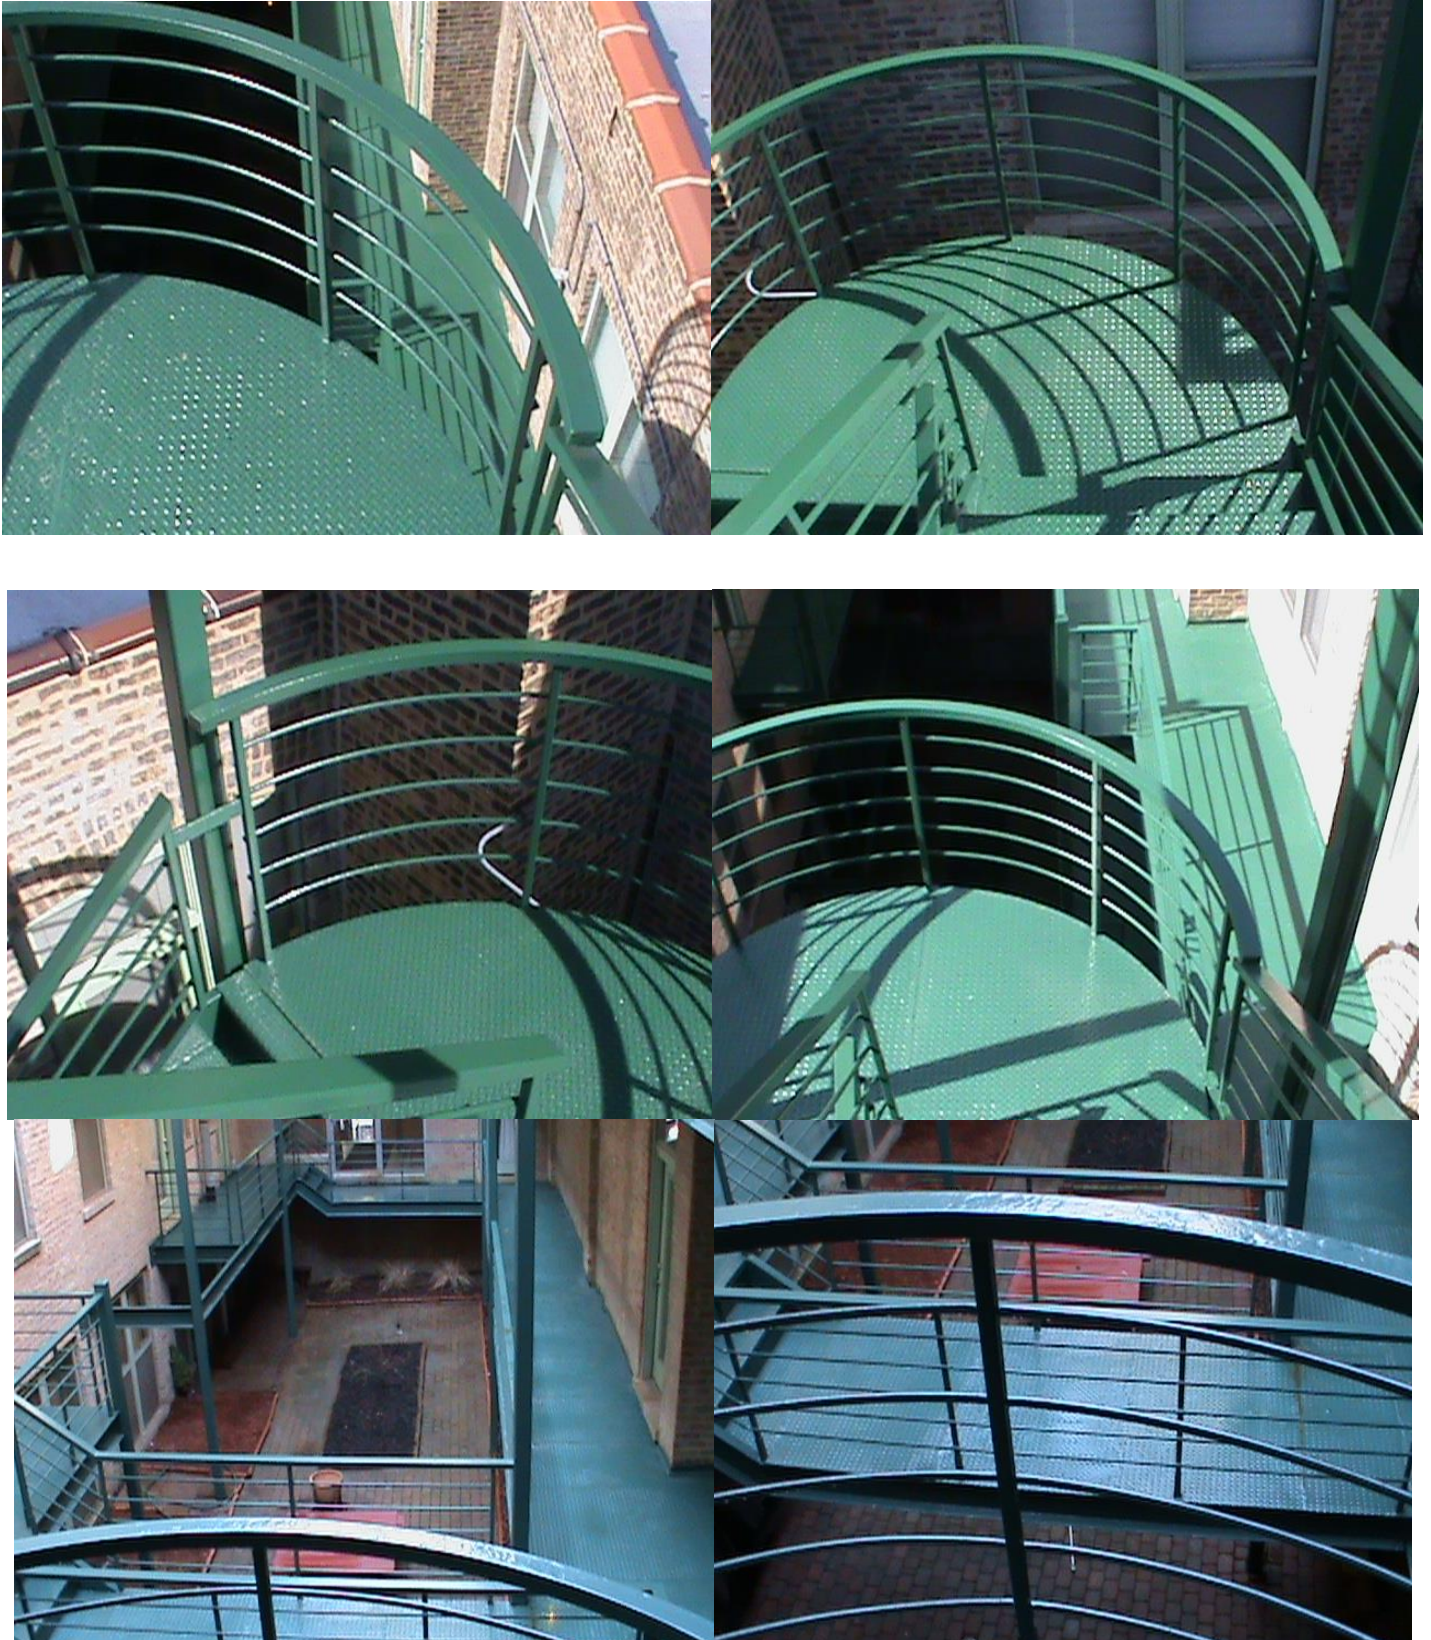
A series of eight readings were taken at the above location. The lowest recorded reading was 18 Mils DFT and the highest recorded reading was 38 Mils DFT. Most readings exceeded 20 Mils DFT.
